## Case study: Gypsum Hopper

TIVAR 88 HIGH PERFORMANCE LINING SOLUTIONS

## TIVAR 88-2 Liners Eliminate Flow Restriction, Adhesion in Gypsum Hopper

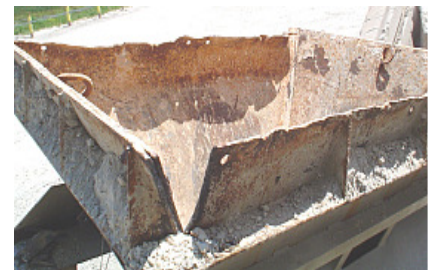
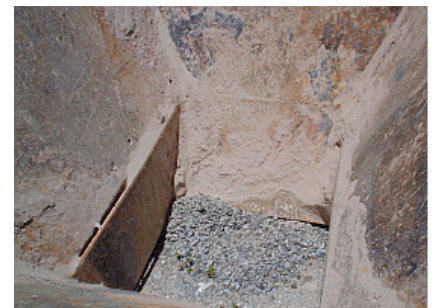
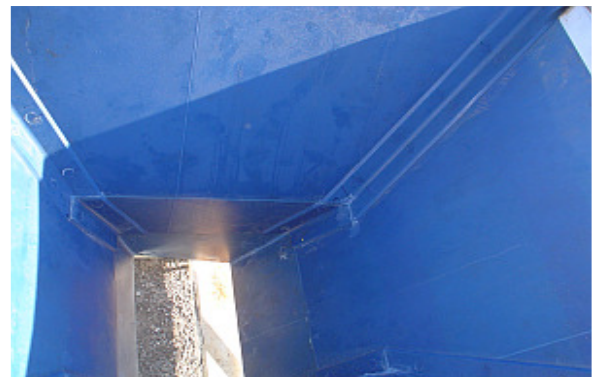
The mud and fines of the gypsum sticks to the sloping steel hopper walls. This resulted in a plugged discharge and conveyor 'blanks' on the feeder conveyor going into further processing.

TIVAR 88-2 liners were engineered and fabricated to fit into existing steel hopper and discharge chute. Steel hopper was re-worked and Tivar 88-2 liners were installed including radiused corners to eliminated corner sticking.

After the TIVAR 88-2 liners were installed, all the build-up and sticking problems have been completely eliminated. Hiccups in feeding equipment were also eliminated. After 3 years of operation, the liners have shown minimal wear. Production staff noted substantial labour savings to monitor and clean the hopper.
